Advanced Electron Beam Nanoprobe Techniques for Electrical Characterization and Fault Isolation

In situ EBIC Measurements of IGBT During Device Turn-on

Greg M. Johnson, Heiko Stegmann
Carl Zeiss Microscopy

EBIRCH Localization for Low-current Soft Fails

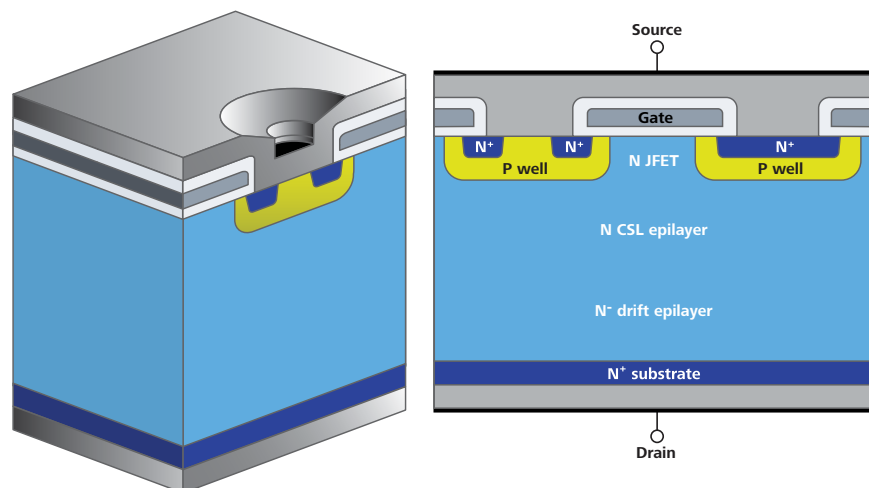
Figure 1 Cross-sectional diagram of an IGBT chip. The views are shown in both a 3D fashion (left) to highlight the structure of the gates, and in 2D to highlight the vertical conduction path through the sample.

An insulated gate bipolar transistor (IGBT) is a three terminal device that acts as a switch. It is a cross between a conventional bipolar junction transistor and a MOSFET and is shown in Figure 1. It is a vertical transistor in that when the device of the insulated gate transistor is turned on, a bipolar transistor allows current to flow through the sample. The device is turned on by first turning on the MOSFET, and then the holes may turn on the internal PNP bipolar transistor. It's a massive parallel device, with gates laid out in a fishbone pattern^[7]. Because it is a vertical transistor, it introduces challenges in any FA technique that needs to look below the surface^[8].

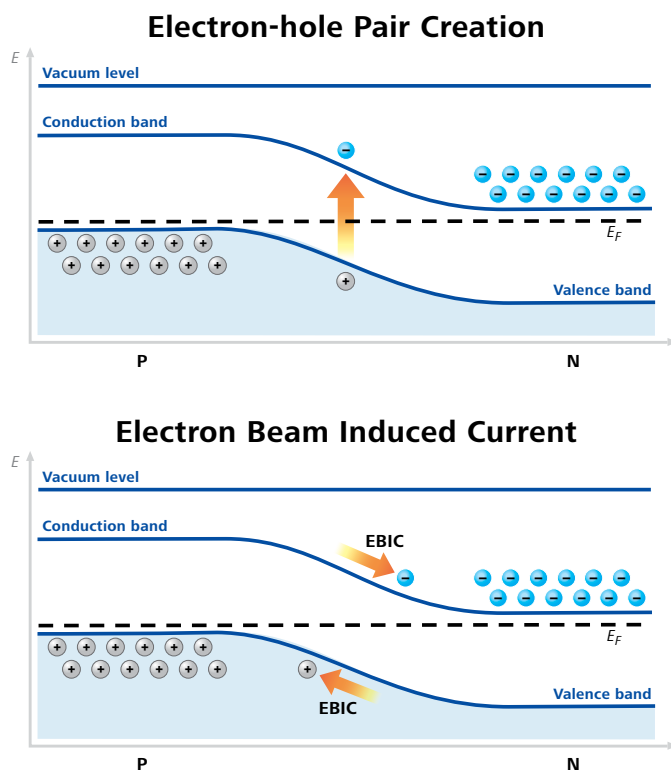
Figure 2 Band diagram for a p/n junction. Top image depicts electron-hole pair creation. Bottom image shows charge carrier movement due to the electric field at the p/n junction, known as EBIC.

The EBIC technique for evaluation of p/n junctions has been widely studied [11–18]. EBIC is driven by internal electric fields that exist at the depletion zone of a p/n junction. If an electron absorbs sufficient energy, it may be promoted to the conduction band (See Figure 2, top), and the event is said to create an electron-hole pair. Then the electric field acts on the charge carriers, and this movement of charge may be detected as EBIC by the placement of a probing needle in the appropriate location, as shown in Figure 2, bottom. As implied by the band shape, this only takes place at the middle of the junction, at the depletion zone. The field is also a vector quantity, oriented normal to the surface of the p/n junction.

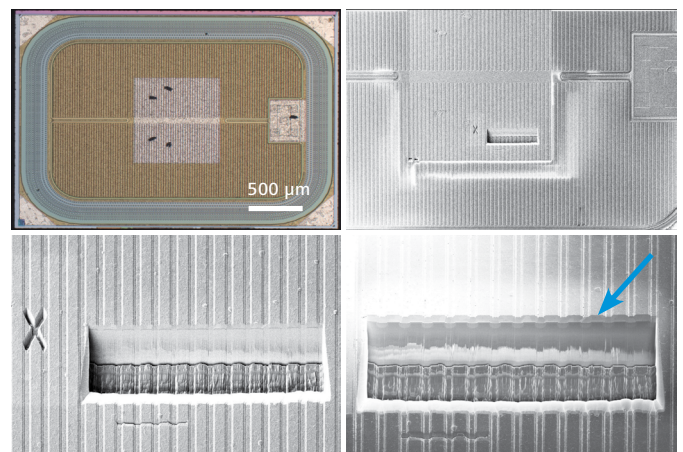
Figure 3 Views of the IGBT chip used in this experiment, and the FIB trench cut into it. Upper left: light microscopy image of the chip before milling. Upper right: SEM image of the location of the trench relative to the visible structure on the chip. Lower left: cut into the structure. Lower right: In-column secondary electron detector SEM image to show the as-cut structure. Already some voltage contrast on the implant regions is visible (blue arrow).

A commercially available IGBT chip was cross sectioned. Various steps in the procedure are depicted in Figure 3. The chip was glued with silver paste to a 12.5 mm aluminum SEM specimen stub. Sputter coating was used to coat the sample with 20 nm of gold. A beveled cross-section was cut across 12 gates in the central area of the device with the focused Ga⁺ ion beam (Ga-FIB) of a ZEISS Crossbeam 350 FIB-SEM instrument. In this process, a 330 μm x 70 μm rectangular FIB shape was used to mill a trench into the untilted sample at 30 kV with 30 nA FIB current for approximately 6 hours. Since the FIB column was oriented at 36° to the horizontal, the opening thus created measured approximately 330 μm x 100 μm on the sample surface. Because FIB cuts tend to show a beam current and material dependent angular offset from the beam incidence, the cross-section was oblique to the sample surface at approximately 34°. The cross-section was then polished at 30 kV with a 3 nA beam using a 330 μm x 5 μm rectangular FIB shape for 2 hours, resulting in a final cross-section angle of approximately 35° to the sample surface. Figure 3, upper right and lower left, show top-down SEM views of the final cross-section, obtained in the same instrument. Although the cross section had some vertical FIB milling ‘curtaining’ artifacts due to the relatively high beam current used for polishing, the passive voltage contrast between p- and n-doped regions stand out using the in-column secondary electron detector of the ZEISS Crossbeam (Figure 3, lower right).

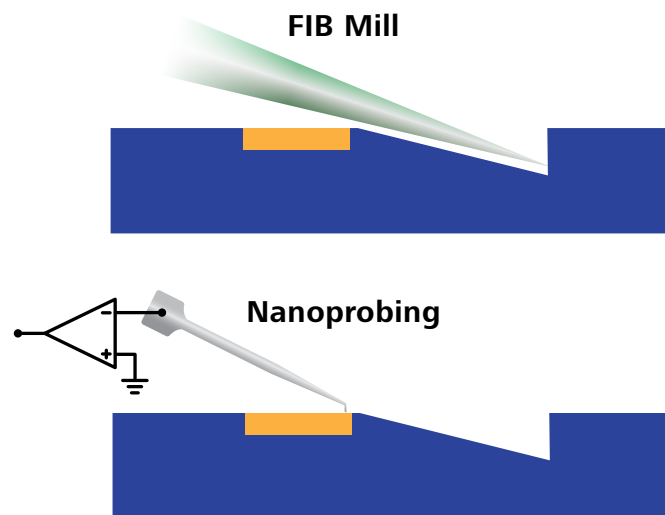
Figure 4 Comparison of the geometric relationships between the FIB milled window and the nanoprobe setup. The green cone represents the FIB beam, and the test pad is shown as a gold rectangle.

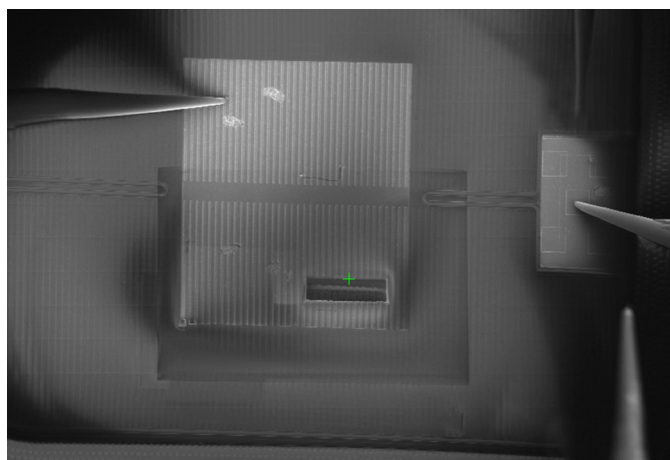
Figure 5 SEM micrograph at 5 kV showing the FIB wedge cut and probes on the emitter and gate pads of the device.

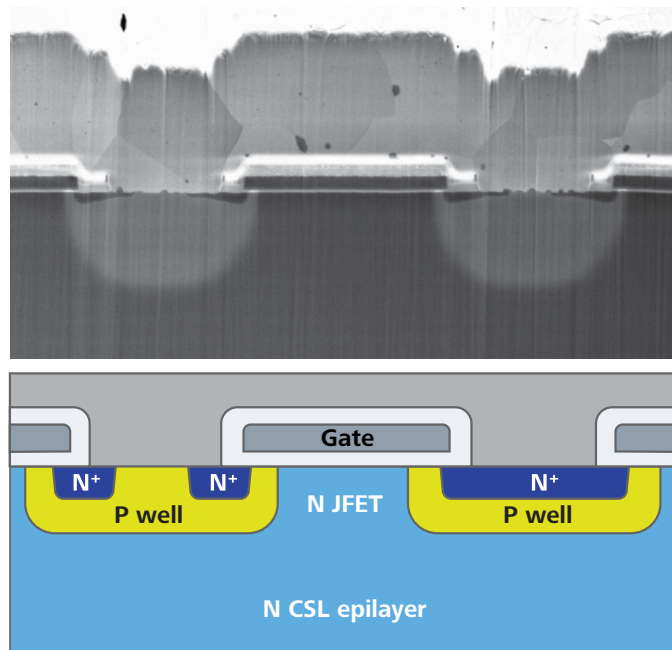
Figure 6 Comparison of the SEI views of the devices in the sample against the layout of a typical IGBT device.

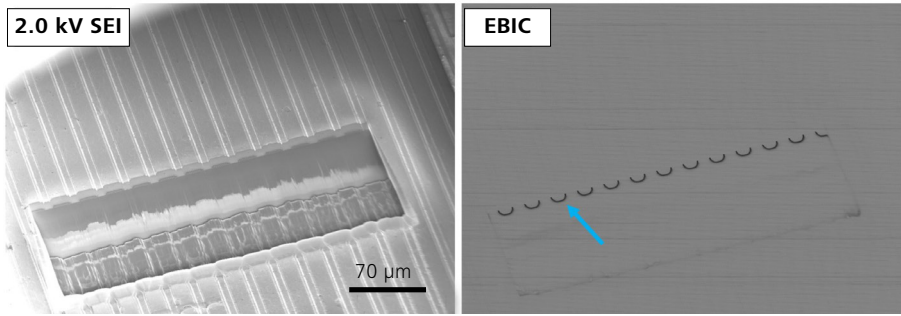
Figure 7 Comparison of the secondary electron and EBIC images of the FIB wedge exposed area in the sample. With a viewing angle normal to the surface, the depletion regions are crisply seen, even at an oblique angle. The blue arrow points to one such depletion zone.

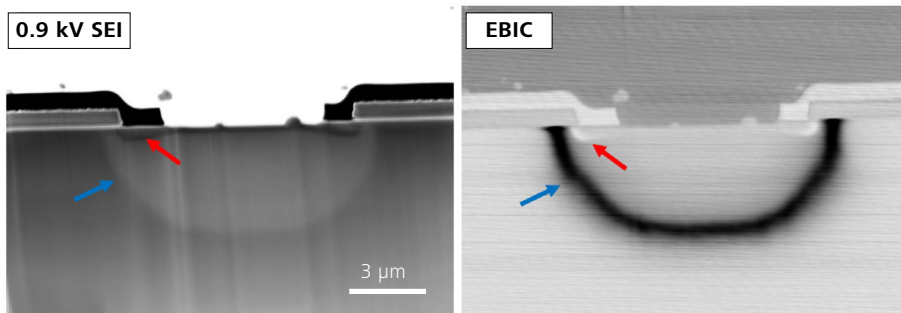
Figure 8 High magnification views of the space between two gates of the IGBT cross section, taken at 0.9 kV. The red and blue arrows highlight two different implant zone interfaces in both images. Left: passive voltage contrast (PVC) in SEI image shows implant types. Right: EBIC image highlights the depletion zones between the two various implants. Note the variation in width and polarity between the different types.

Closer examination with EBIC and SEM examination, at higher magnification in the area between two gates is shown in Figure 8. Even though the exposed surface is at approximately 35° angle to the surface normal, depletion zones are easily measured. These results highlight a major benefit of this work, in that it is possible to pick an area on the surface of the sample, and examine p/n junctions there, without major deterioration of the device.

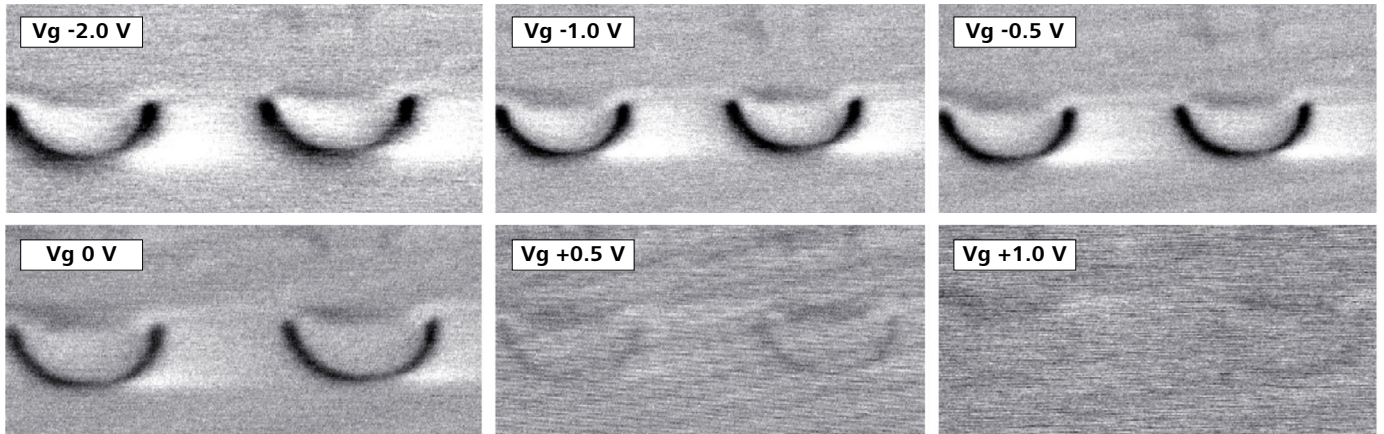
Figure 9 EBIC images of the depletion zones between the P- body and N- emitter as a function of gate voltage.

The next set of experiments involved measuring EBIC at the emitter pad, under stimulation of a 0.9 kV SEM beam, while at the same time, incrementally varying the gate voltage on the gate pad, in a range from -4.0 V to +4.0 V. A sampling of the results is shown in Figure 9. Once again, both types of depletion zones are visible. It was decided however to concentrate on conditions which would optimize the “smile” of the P- body to N- drift region, the one that would be critical to device turn-on. In the measurement series, at negative voltages, the depletion zone becomes slightly wider, darker (meaning more negative currents) with increasingly negative voltage. However, as the voltages cross into positive territory, the depletion zone fades into non-existence. This is to be expected, as the inversion of this channel must occur in order to allow current to flow from top to bottom of the device. This is the stage in device switching that relates to the turn-on of the insulated gate portion of the transistor. This result of a uniformly inverted channel, all the way across the “smile”, should be expected from physics, but is not what is typically shown in most sketches in tutorials as to what occurs upon device turn-on. These seem to imply the only conduction path would be immediately underneath the gate. In contrast, the results presented here show that the whole depletion zone inverts as the gate is biased positively. In this regard, the authors highlight this finding as a likely novel and important contribution to the operation of IGBT turn-on.

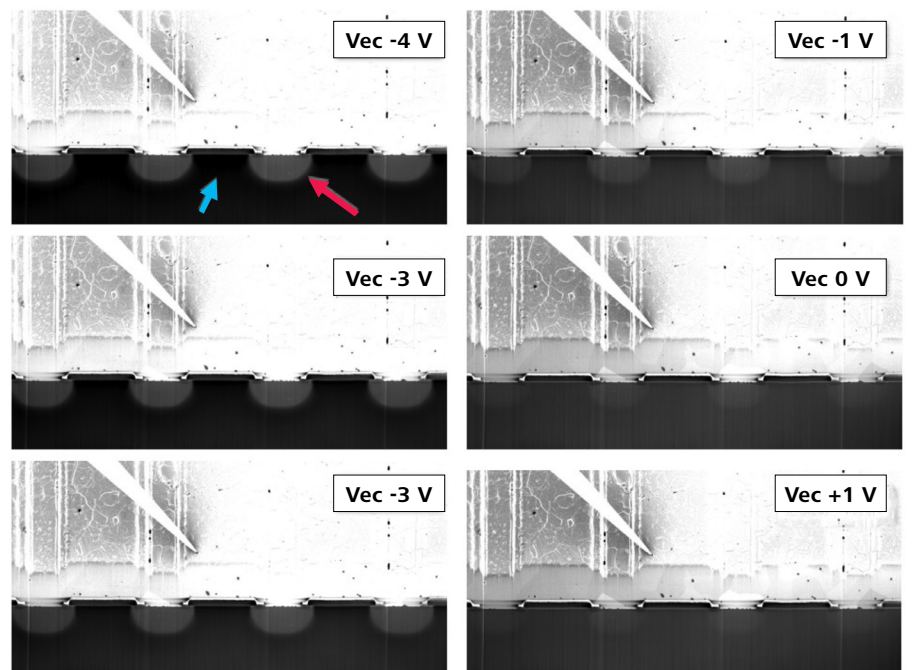
Figure 11 Active voltage contrast images of the device in cross section, examined with various values of V_{ec} . The red arrow highlights the P- body region; the blue arrow highlights the much darker N- drift region. A sampling of the voltages in the experiment is shown here.

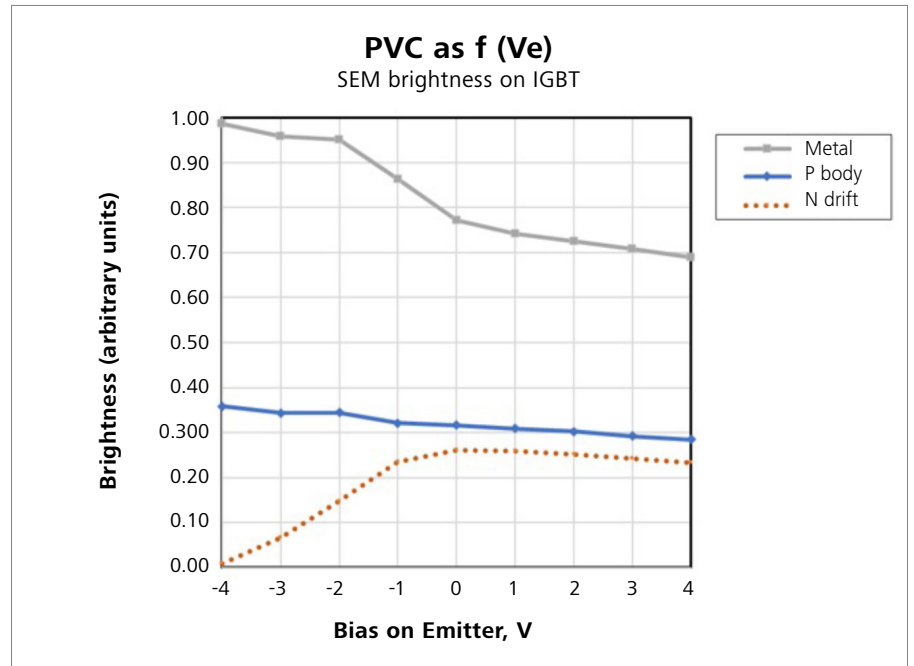
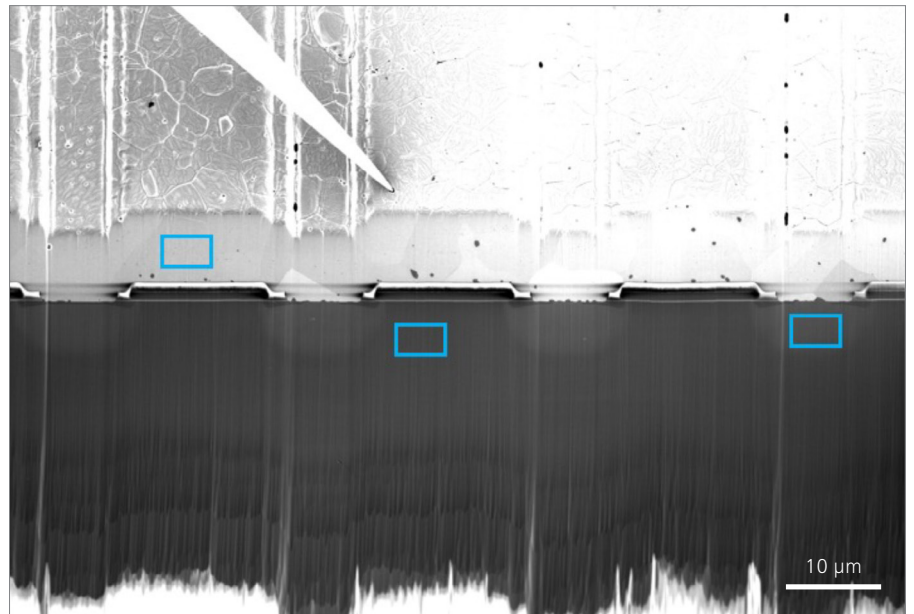
Figure 12 Plot of relative brightness in the SEM image across 50 pixels for each of metal, P-, and N- regions in the AVC study. The blue boxes highlight the areas compared on each of nine different images.

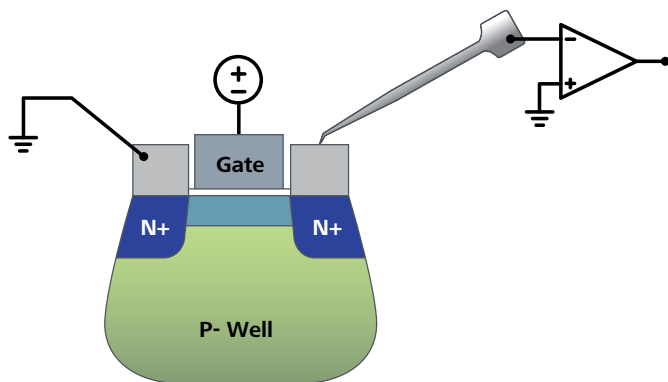
Figure 1 Diagram describing the experiments undertaken. A transistor is grounded on one side. Various voltages are applied to the gate, and then the current is measured at the other contact, which is also grounded.

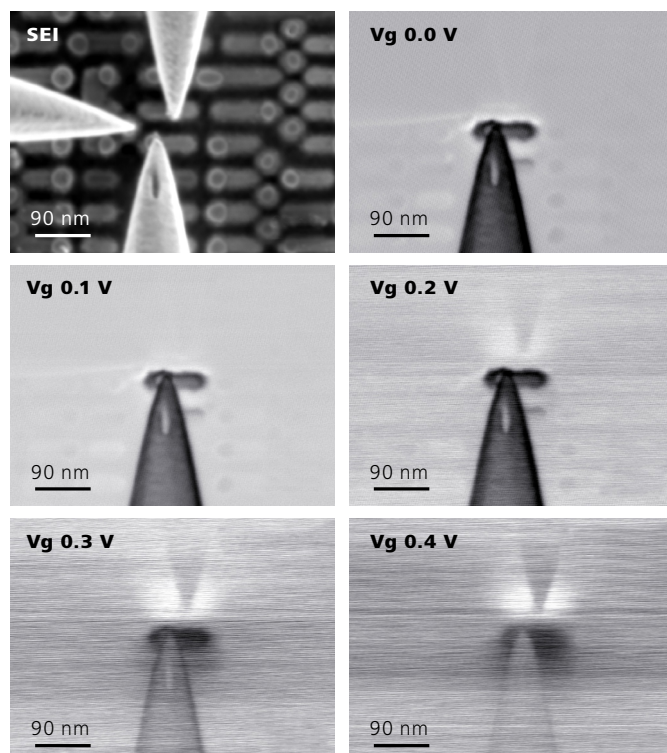
Figure 2 Previous work^[4] demonstrating device turn on in an nMOS 7 nm logic device. Note that the signal is uniformly strong across the surface of the contact itself. This is incompatible with the distribution of EBIC signal expected if the phenomenon were instead due to the electrons “bleeding around” the edge into the underlying silicon.

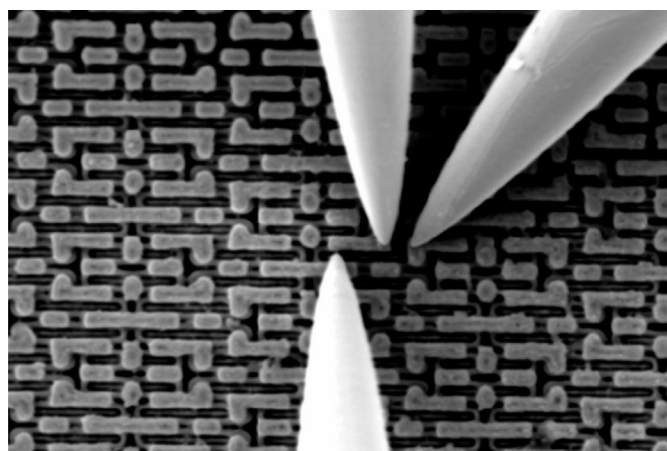
Figure 3 Low mag view of 22 nm SRAM examined in this study.

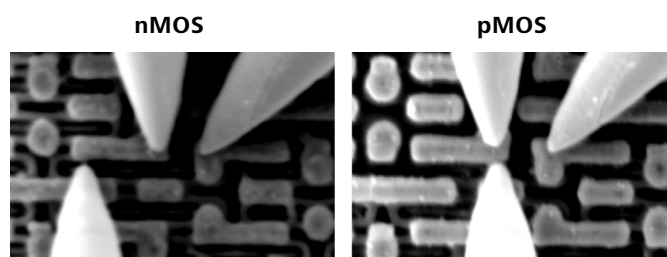
Figure 4 SEM view of the devices probed in the 22 nm sample.

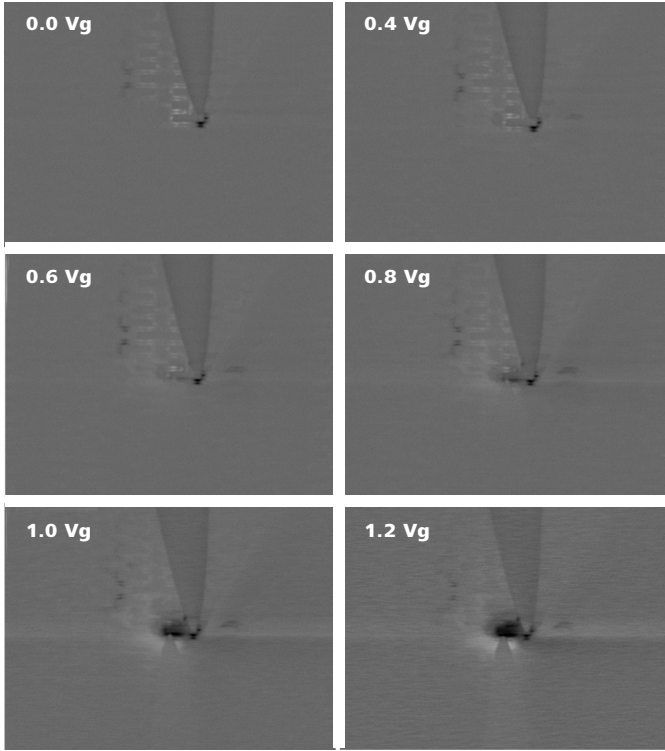
Figure 5 EBIC results on 22 nm nMOS device for a series of experiments with both source and drain grounded, but an increasingly higher gate voltage, from 0.0 V, 0.4 V, 0.6 V, 0.8 V, 1.0 V, and 1.2 V.

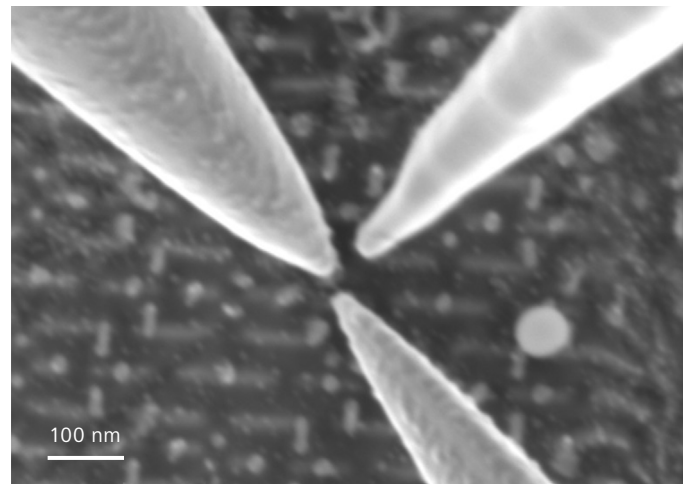
Figure 8 Field of view for the measurements on 5 nm device.

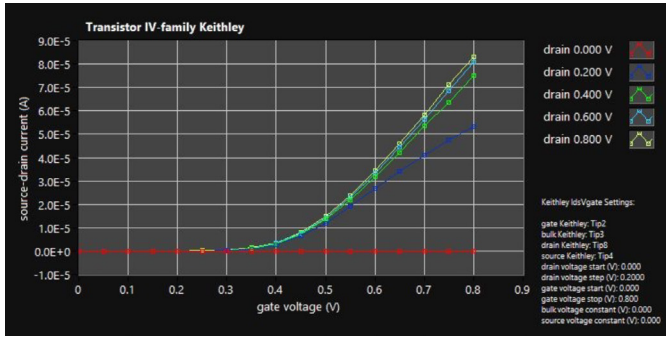
Figure 9 Transistor family of curves for 5 nm nMOS, providing reassurance of quality and integrity of devices upon delayering.

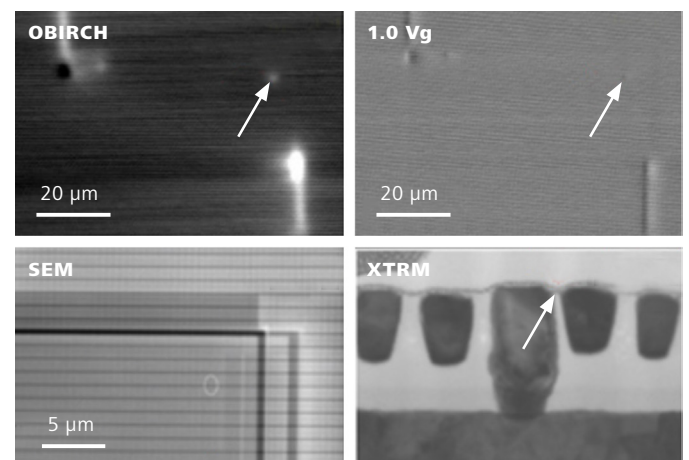
Figure 11 Example of the use of EBIRCH to localize a short in a BEOL via chain. No p/n junctions are involved, and the cross section showed the short involved a liner interface, which would have introduced a material (Ta) with very different Seebeck coefficient from Cu. From [5]

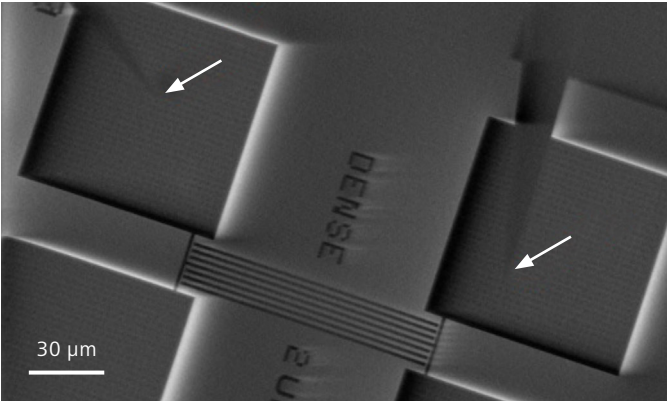
Figure 12 Example of EBIRCH analysis at 30 kV on a BEOL test structure (containing no p/n junctions). Note that there is no signal at the interface between copper test pads and the probe tips (red arrows). Johnson, unpublished work.

Additional evidence that Seebeck effects readily happen in nanoprobing is shown in examples where the tungsten probe tip is in direct contact with material and is in the field of view during imaging. One such example is shown in Figure 12, which represents an attempt to perform EBIRCH analysis on a BEOL test structure, which does not even contain any p/n junctions at all. The red arrows point to the places where a tungsten needle is in contact with a test pad, and there is no effect in these places. Tungsten and copper have very similar Seebeck coefficients, and thus no Seebeck effect is noted. (Meanwhile, a slight effect is actually seen at the edge of the pads, and this may actually be due to a Seebeck effect between the linear of the test pads and the test pads themselves).

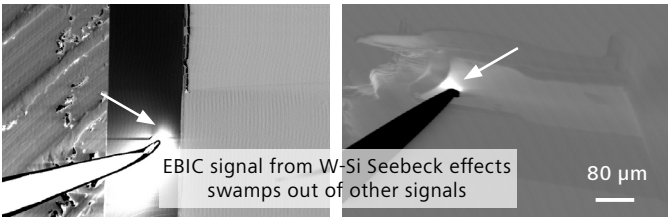
Figure 13 Examples of the typical EBIC/EBIRCH effects observed when a tungsten probe tip touches bare silicon. Left, lamella prepared from an IGBT device. Right, cleaved cross section of an SiC MOSFET. The signal is swamped out at the point where the tungsten needle hits silicon. It is proposed that the Seebeck effect of this interface swamps out any EBIC signals within the device cross section.

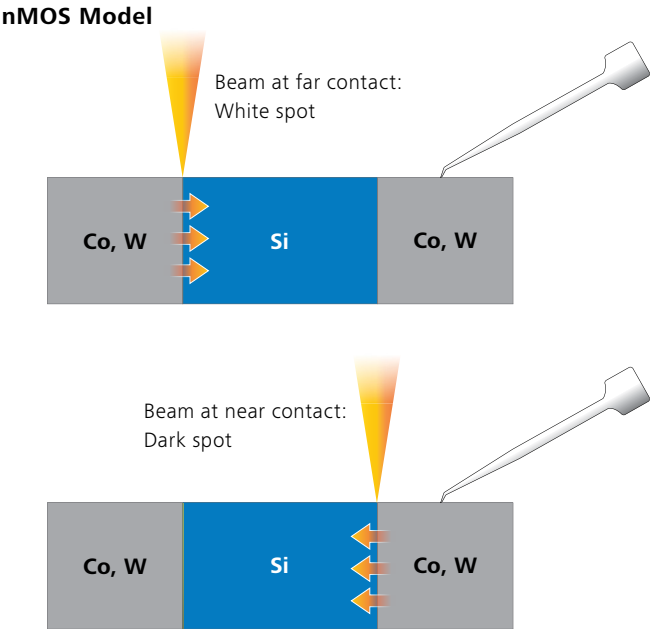
Figure 14 Model for nMOS case, considered with the gate open. As beam hits the W/Si (or Co/Si) interface at the far contact, the Seebeck electromotive force helps drive a current into the probe, and reported as a white spot. As the beam hits the near spot, the Seebeck effect has the opposite effect as seen from the probe tip and is reported as a dark spot.

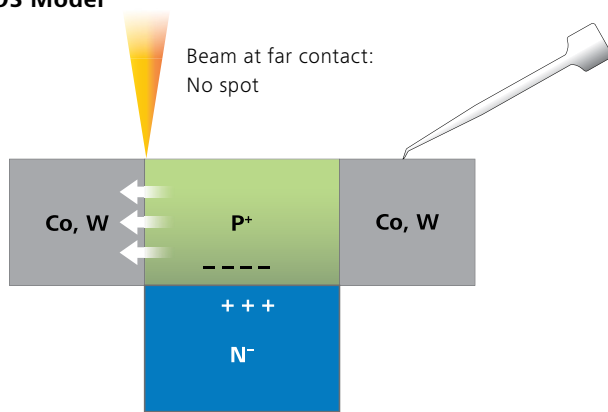
Figure 15 Model for pMOS case. Even if Seebeck effects of similar magnitude exist, any flux of electrons will find a sink in the positively charged N-well, due to the built-in potential of the junction.

However, a mechanism becomes more clear when one considers that the pMOS contact is sitting on top of a p/n junction, where the built-in potential provides a sink for electrons. (Alternatively, one might think of it in terms of the orientation of the field at this junction). Thus, any effects taking place at these interfaces might not be detected at the probe tip. That this might not cause a problem for the N^+/PW junction underneath the nMOS contact is left as an exercise for the reader.

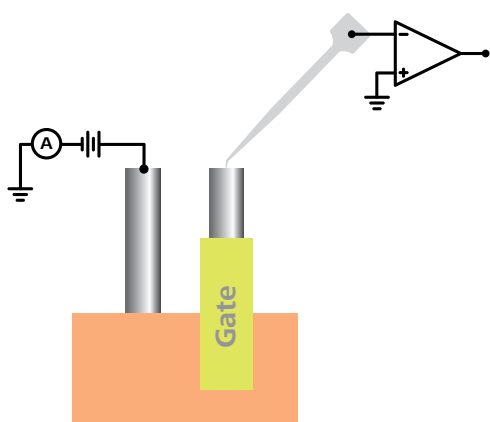
Figure 1 Pictorial view of EBIRCH setup, consisting of two probes, a voltage source, and a means to monitor current. Pictured here is possible probing arrangement in an SRAM.

to be a powerful technique for device characterization and defect localization^[4, 5]. EBIRCH involves applying a voltage across a circuit, typically between two nanoprobe, and determining the change in resistance or impedance across the device^[6]. This is depicted schematically in Figure 1.

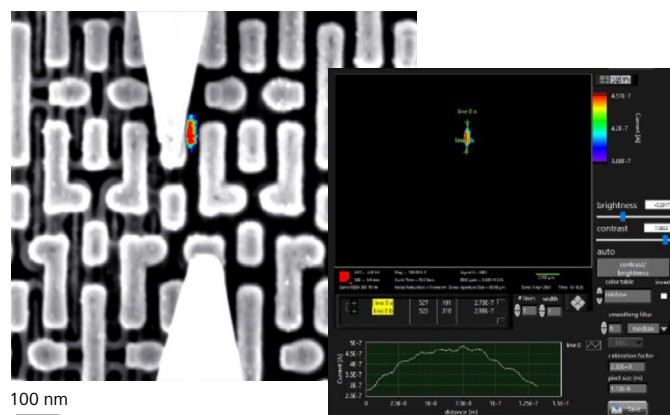
Figure 2 EBIRCH result for SRAM cell taken to 3 V of stress between source and gate, without compliance. Left image is SEM + EBIRCH overlay; right is quantitative analysis. This analysis showed a doubling of the current across the device, from 280 nA to 480 nA, due to beam stimulation.

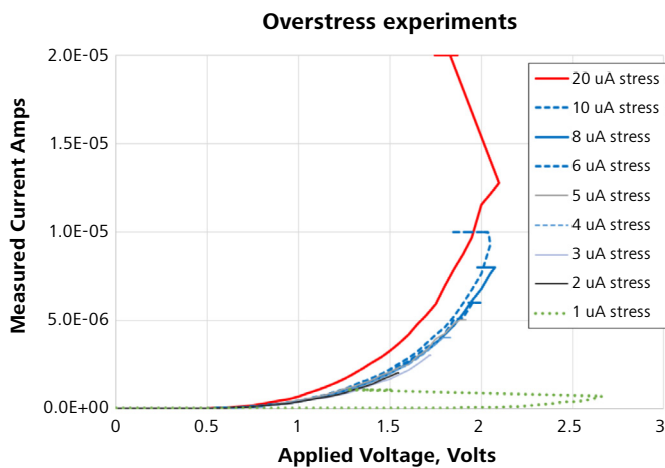
Figure 3 Typical voltages and currents recorded during the overstress experiments. Voltage applied between source and gate of the same pulldown device of a delayed 22 nm SRAM. The 1 μ A stress resulted in the device reaching 2.7 V. The rest of the stresses resulted in very similar curves, each ending at the nominal current. The applied voltages decrease as a result of the compliance function.

In order to estimate the lowest possible leakage current that could be detected, an experiment of successively higher stresses was undertaken. First, a new device within the same array was chosen, and the baseline current was determined, by applying a voltage up to 1.5 V with a Keithley 4200A SCS source-meter unit. Then, a series of voltage stresses nominally up to 2.5 V were applied, starting with 1 μ A, then 2 μ A, 3 μ A, 4 μ A, 5 μ A, 6 μ A, 8 μ A, 10 μ A, and 20 μ A. The results are shown in Figure 3. One can see that the maximum currents reach no higher than the stated compliance, and the maximum voltage actually decreases during the run. In order to prevent it from going higher than the specified current for the “1 μ A” curve, the device was stressed up to 2.7 V before hitting the compliance current. Meanwhile, the 2 μ A, 3 μ A, 4 μ A, 5 μ A, 6 μ A, 8 μ A, and 10 μ A curves almost (or nearly) lie on top of each other. For the 20 μ A curve, there is a significant change to the shape of the curve, hinting at some alteration of the device.

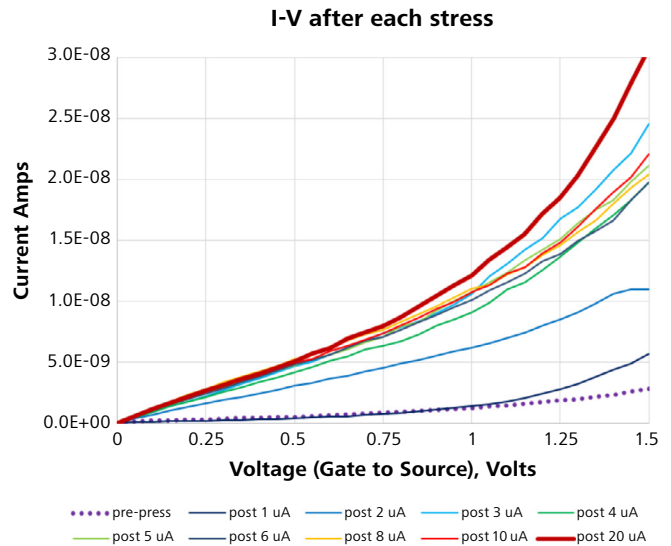
Figure 4 Current-voltage curves between source and gate for each successive stress in the experiment. Nine successive stresses applied. The current ultimately increased 10x. The bold lines at top and bottom of plot represent pre-stress and post-20 μ A stress, respectively.

Next, after each run, a corresponding I-V measurement was recorded between source and drain. These results are displayed in Figure 4. A total of ten curves are displayed, starting with the baseline (purple dotted line), increasing up to the maximum current of the experiment (thick red line). The currents tended to follow a steady increase, with the exception of an unexpected increase after the 3 μ A run (sky-blue, or second-highest curve). It should also be noted that all of the I-V curves follow a shape with gradually increasing slope: no straight lines. This is an indication that we have no ohmic conduction, and therefore no metallic bridges creating shorts.

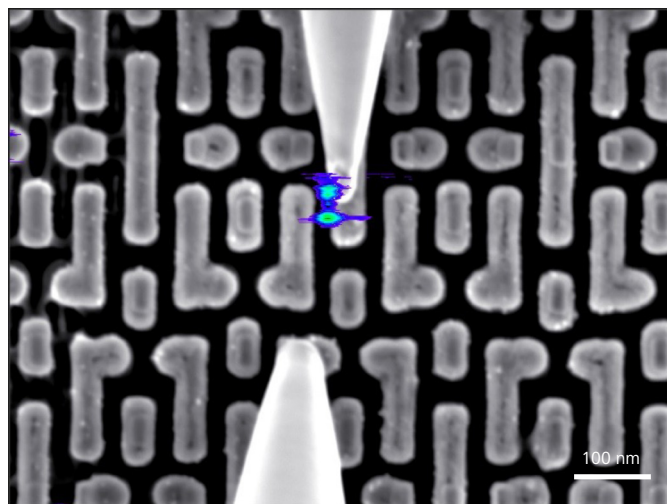
Figure 6 SEM + EBIRCH overlay after 20 μA stress, nicely highlighting the two fins of the pulldown device.

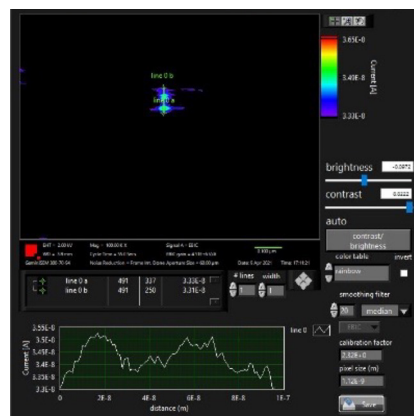
Figure 7 Quantitative measurement of the EBIRCH response from 20 μA over stress. Note that the absolute value is not calibrated, but there is a 2.5 nA increase in current upon beam stimulation.

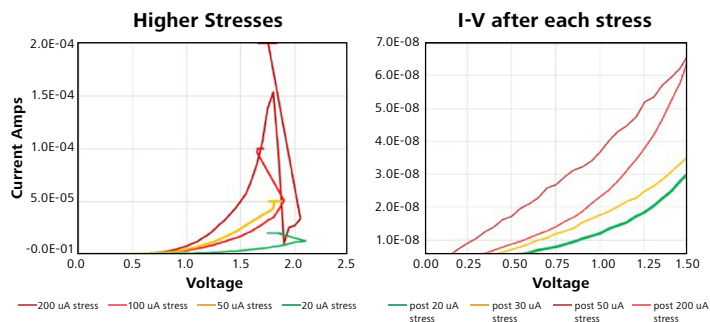
Figure 8 Stress curves at subsequently higher compliance settings, and a measurement of the current up to 1.5 V after the stress. The highest stress, 200 μA , eventually led to an ohmic short.

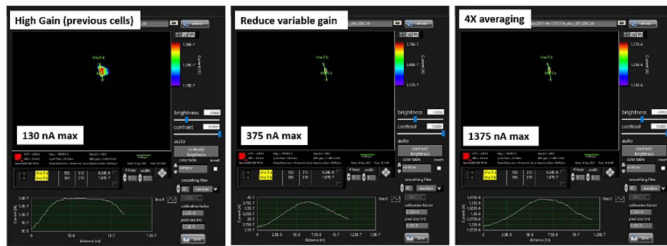
Figure 10 Additional scans post 200 μA with various analysis conditions. The increases remind that EBIRCH is a measure of alteration by the beam, not the raw current.

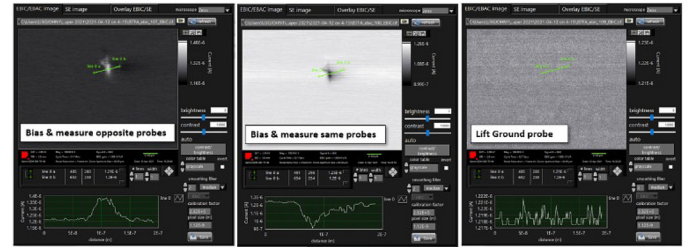
Figure 11 Experiments varying the probing conditions. Left: Bias, EBIRCH on different probes; Middle: Bias & measure same probes. Right: Lift the ground probe.

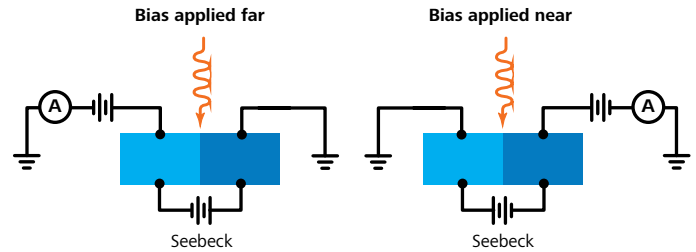
Figure 12 Explanation of the arrangement for EBIRCH experiments with “bias applied far” and “bias applied near”. The EBIRCH technique can be likened to an ammeter. The two colors of the conduction path highlight that there are dissimilar materials in the conduction path. An electron beam scans from above. The effect of beam heating, according to the Seebeck effect, provides a voltage boost across the interface.

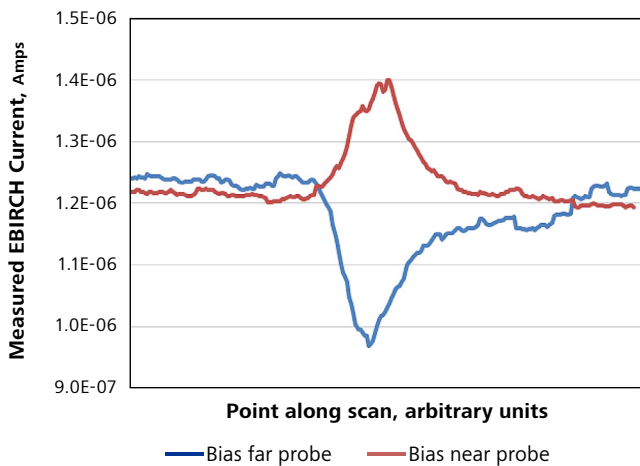
Figure 13 Comparison of EBIRCH currents for two EBIRCH scans of same field of view, with probe bias either near or far.

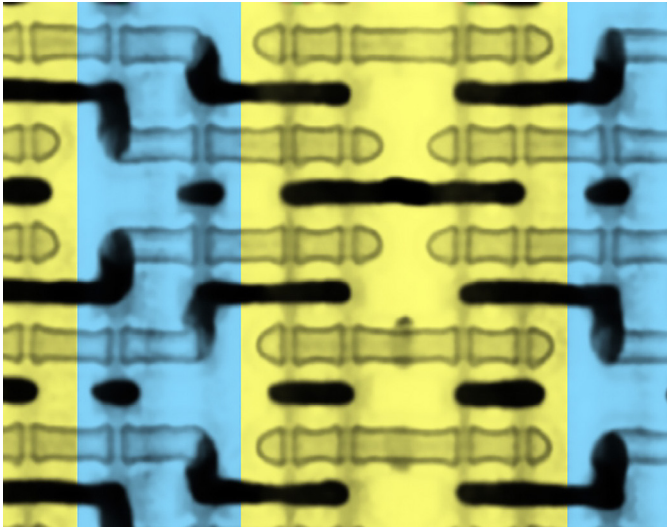
Figure 1 Pictorial view depicting nFET or P-well (yellow) and pFET or N-well (blue) regions of a typical SRAM sample. These are displayed as color coding of a backscattered image from a different chip polished to a deeper plane than used in this study.

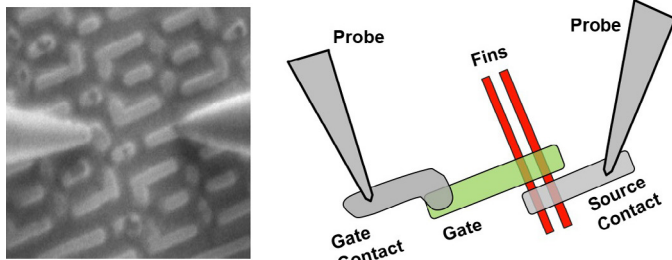
Figure 2 Pictorial view of structure under investigation, with the probes used for both the overstress operation and the subsequent EBIRCH analysis. Left, SE image; Right, schematic view.

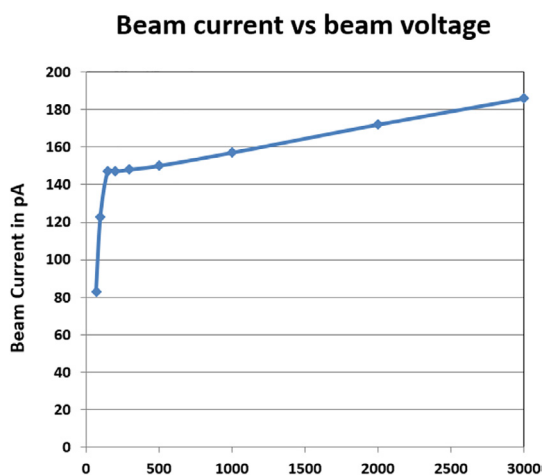
Figure 3 Measurements of beam current with a Faraday cup performed under identical conditions to those in this paper.

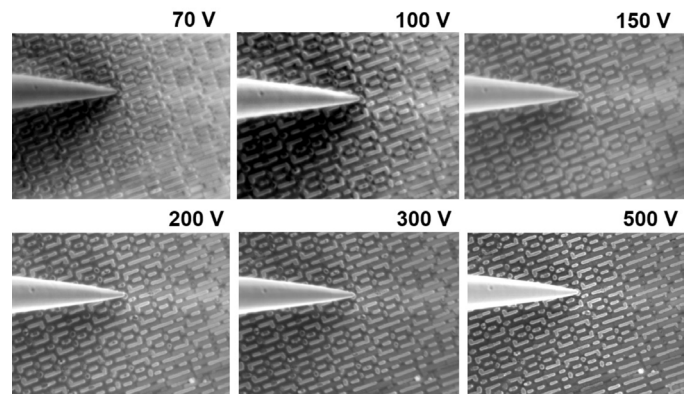
Figure 4 SE images taken at six different acceleration potential of a 7 nm SRAM with a GeminiSEM 300, showing excellent resolution, even below 100 V.

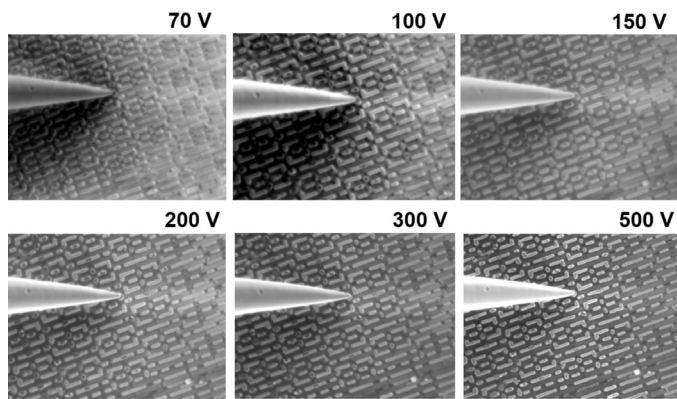
Figure 5 EBIC images taken at six different acceleration potentials, before intentional overstress. The images show a progression from surface to deeper effects. pFET contacts light up very strongly under these conditions.

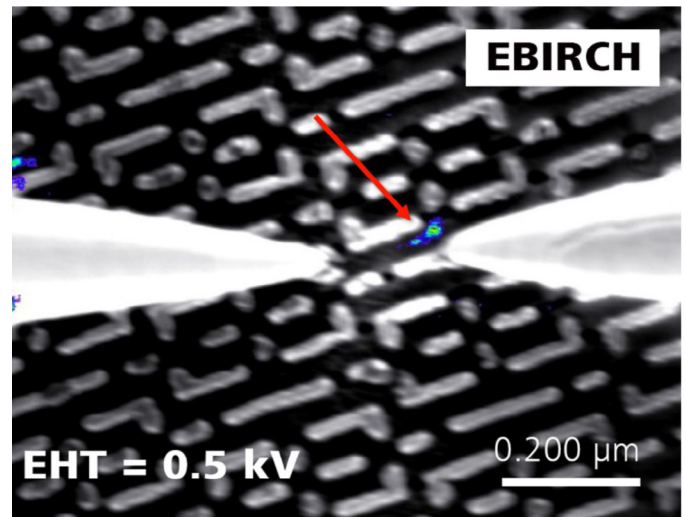
Figure 7 SEM with EBIRCH-overlay the sample after electrical stress. Note that there is no crater or blowout seen top-down in this image. EBIRCH shows spots near one fin and likely along a fin sidewall.

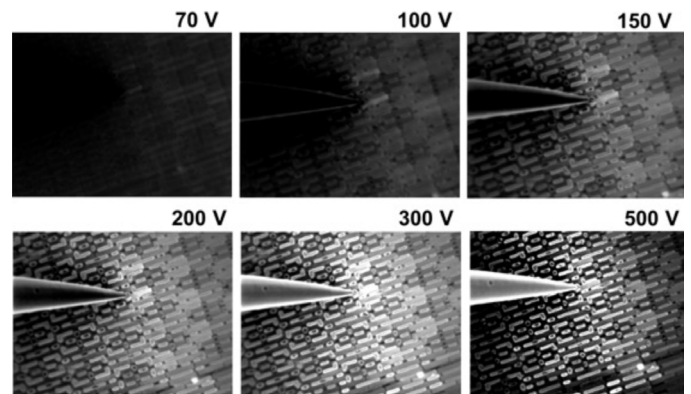
Figure 8 Post-blow EBIC images taken at a variety of acceleration potentials. The background signal is much higher than in Figure 3, which will be discussed in greater detail in the text.

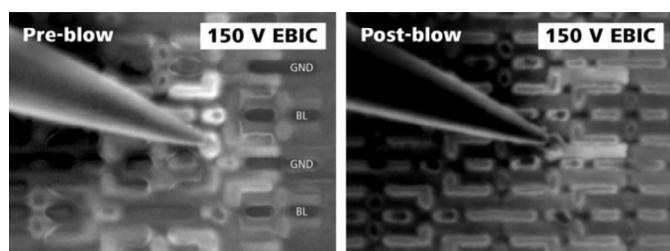
Figure 9 Beam voltage 150 V, pre-blow left and post-blow right side, as-recorded EBIC images. The location of nFET contacts (Bitline and Ground) are overlaid in the image to highlight the contrast of each type. The post-blow image shows that most of these contacts now light up.

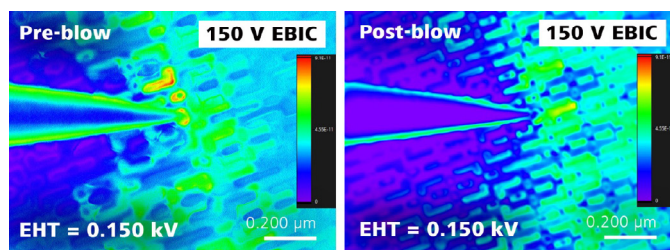
Figure 10 Color maps quantitatively displaying the current absorbed at each pixel. The gate that has been probed stands out somewhat more strongly than its peers.

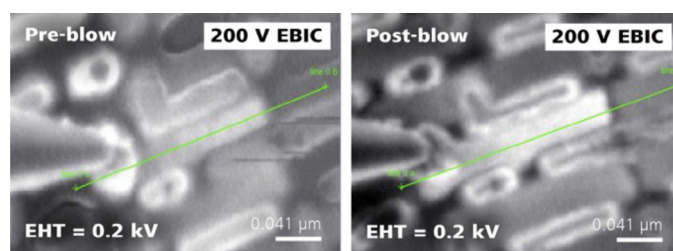
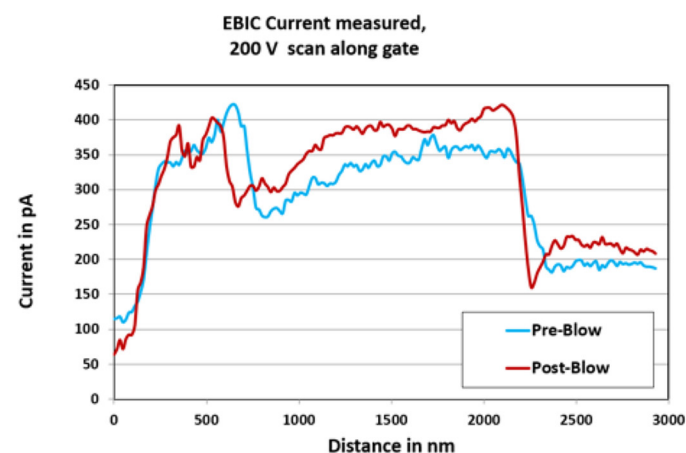
Figure 12 EBIC current measured along the failing gate and a part of a following intact reference gate. Top views are EBIC images; graph numerically compares data along the scan.

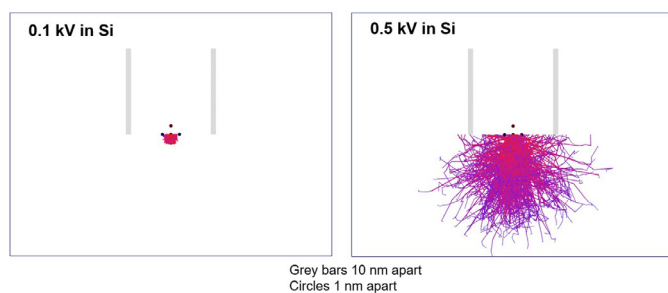
Figure 13 Casino models for 100 and 500 V electron beam scattering in silicon.

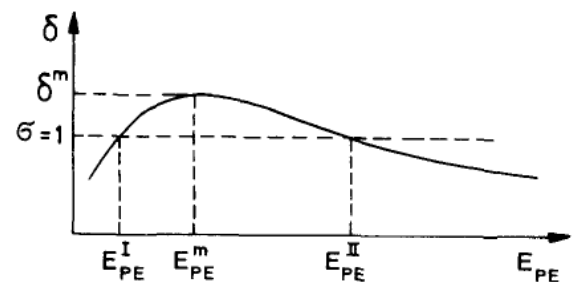
Figure 14 Plot of Secondary electron yield (δ) as a function of primary electron beam, from Seiler. At E_I , the sample has no net or loss of electrons. Above E_I , the sample charges positive.

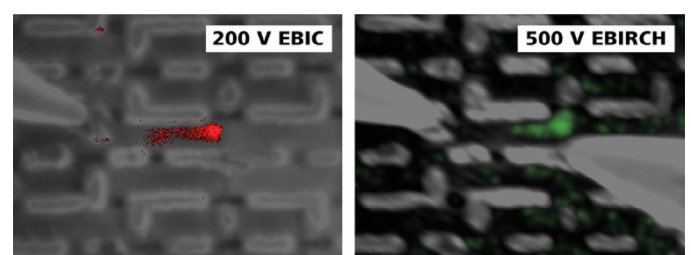
Figure 15 Comparison of EBIRCH, EBIC, and overlay of the two data sets. In the left image, EBIRCH data are overlaid with green; in the right EBIC is overlaid in red.

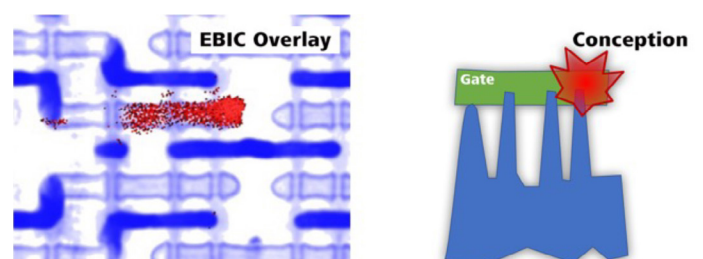
Figure 16 Left: Overlay of EBIC data (red) from this analysis with BSE image of similar devices (blue); cartoon depicting model for fail that unites both data (right).
